An evaluation of 316L tensile tests

Fachhochschule Dortmund

Dr.-Ing. Farzad Foadian

The samples obtained by Sharebot on 21.04.2021 from 1.4404 were examined. The execution was carried out by Robert Kremer (robert.kremer@fh-dortmund.de) at the FH Dortmund.

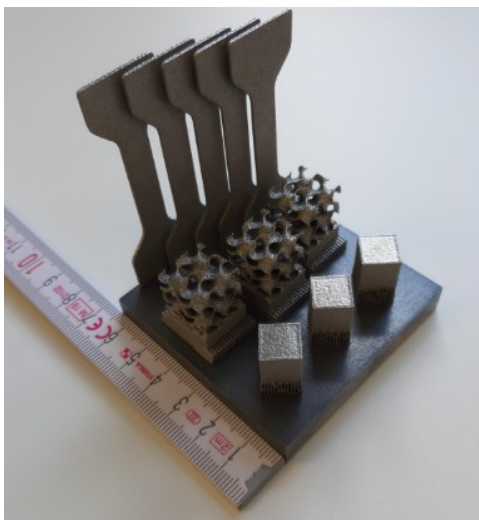
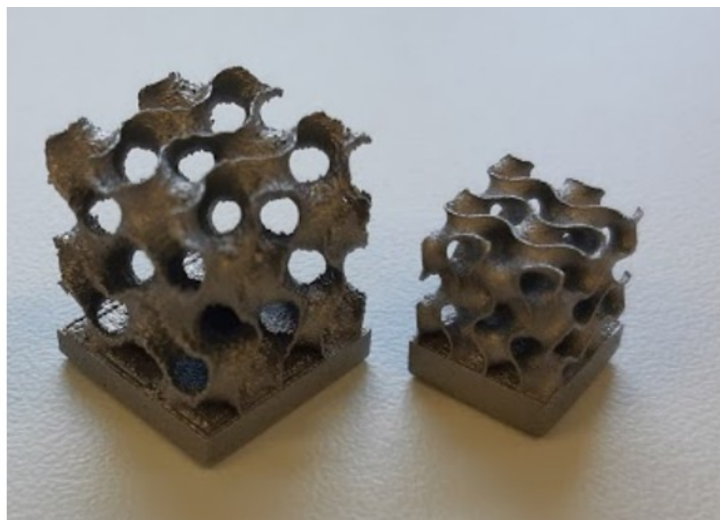
Fig. 2 Samples received on the construction plate **Fig. 2** lightweight cubes in comparison; On the left, the submitted and on the right the own

It is noticeable that the lightweight cubes are larger than required. In addition, the resolution is significantly lower, indicating a larger melting track (more volume energy and/or higher layer thickness) than with the reference sample.

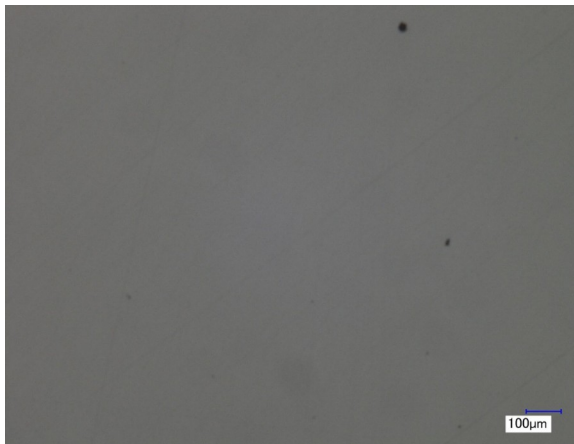
Fig. 4 Polished cross-cut

The two samples were then embedded, sanded, polished and viewed under the microscope. A high density within the component is noticeable.

In the periphery there is an accumulation of pores.

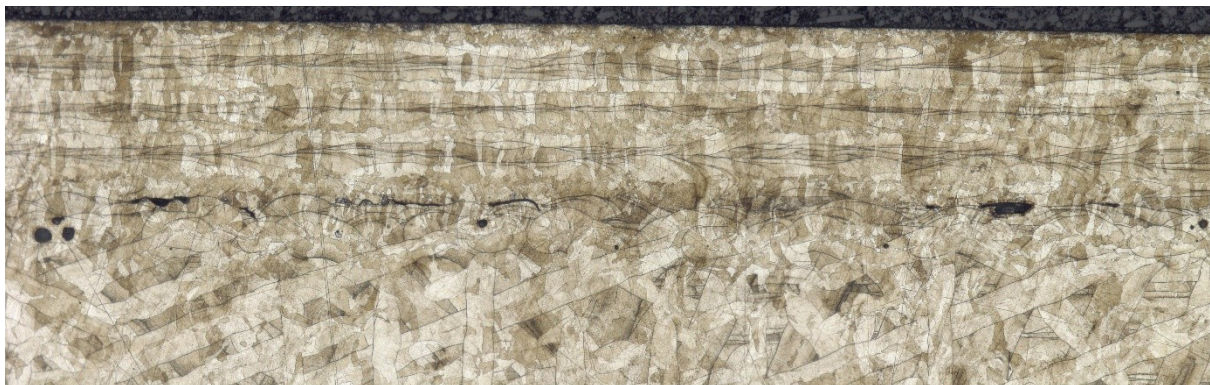
After the subsequent etching, it becomes apparent that the edge and surface exposure is not fully connected, which causes the pore accumulation.

Fig. 6 Etched recording of the edge area with visible errors in the transition area

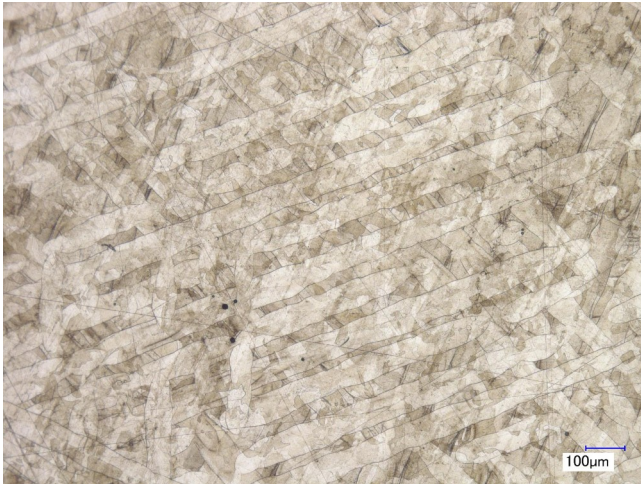
Overall, the cut images have a typical appearance with visible melting traces.

Fig. 7 Etched plan view with visible melting traces and applied alternating exposure

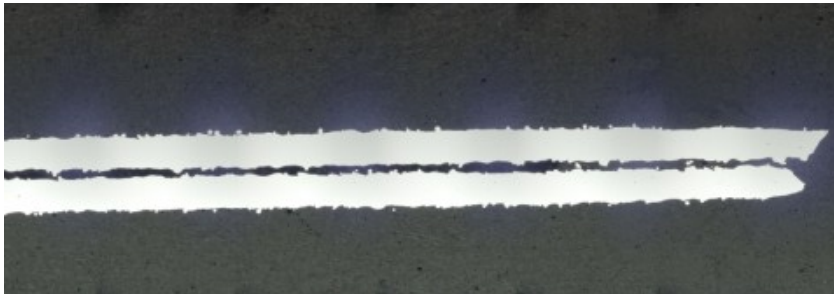
All five tensile samples have a gap in the middle, which is only interrupted by a few bridges. One possible explanation could be the interplay between surface and edge exposure.

Fig. 9 Ground cross-section of the drawn tensile sample. Clearly recognizable gap within the component

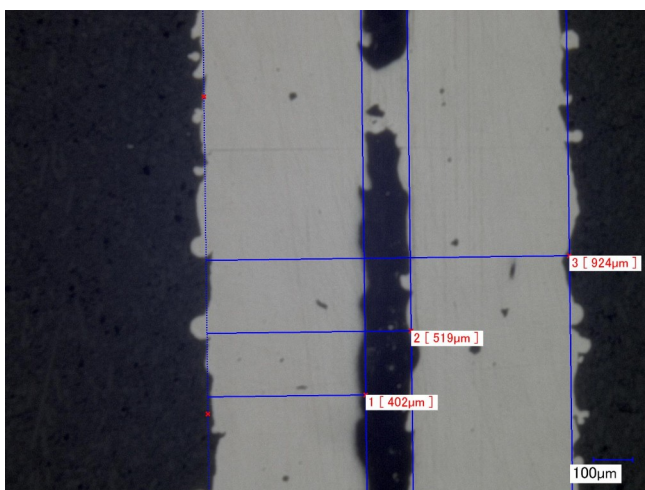
Fig. 10 Measurement of the gap within the tensile sample

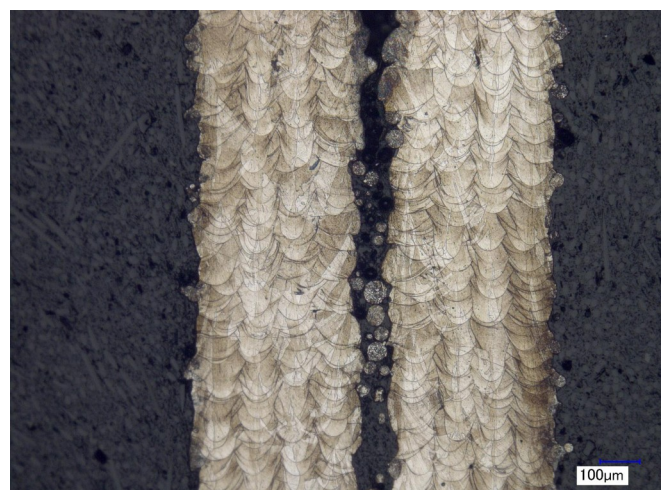
Fig. 11 Etched view of the tensile sample

In the etched cut pattern, unmelted powder particles can be seen in the middle.

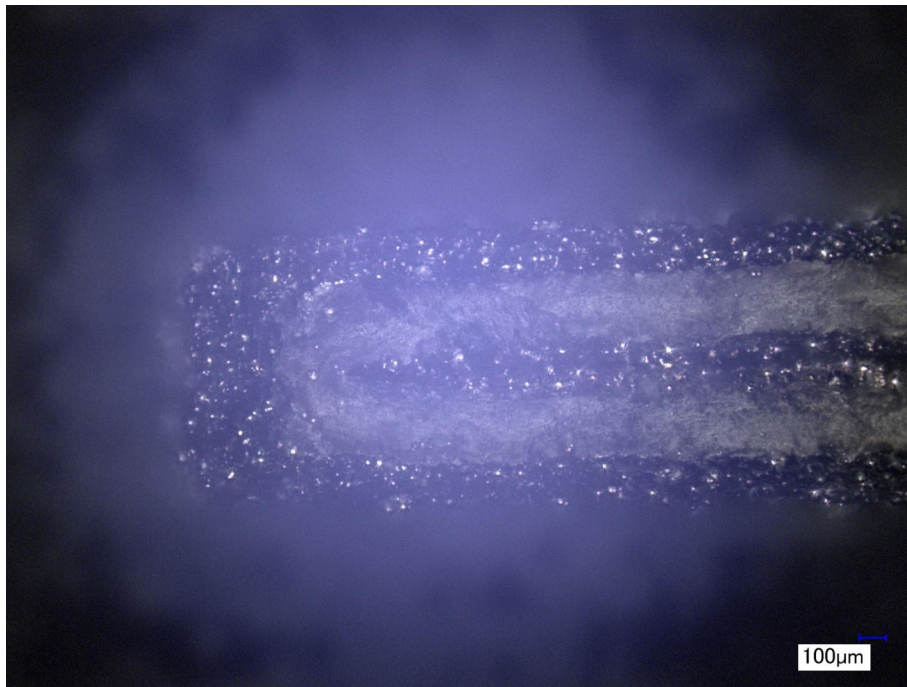
In the reception of the fracture point, the gap, including adhering particles, can also be seen.

Fig. 12 Plan view of the fracture site

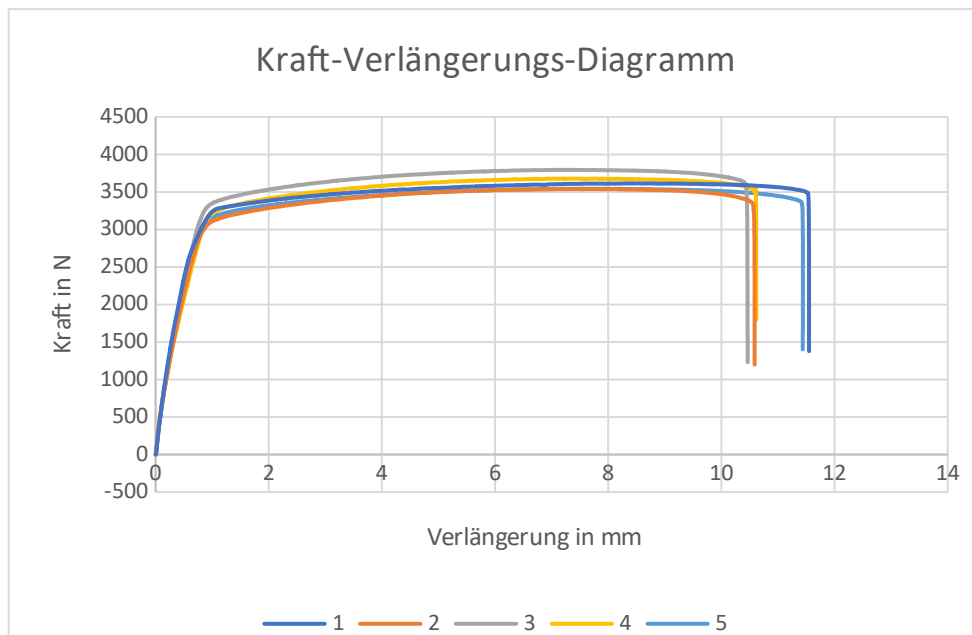
Due to the incompletely constructed tensile samples and the resulting unknown or fluctuating cross-section, only a force-extension diagram is output.

The cross-section estimated on the basis of the microscopic images is 6.4 mm^2 , which corresponds to a tensile strength of approx. 570 MPa (according to literature 500 – 700 MPa). Due to the problem described, however, the value is only partially meaningful.
